## Durable Hydrophobic Surface Treatment for Enhanced Corrosion Protection Small Business Innovation Research (SBIR) Grants for branches of US Military

### Introduction

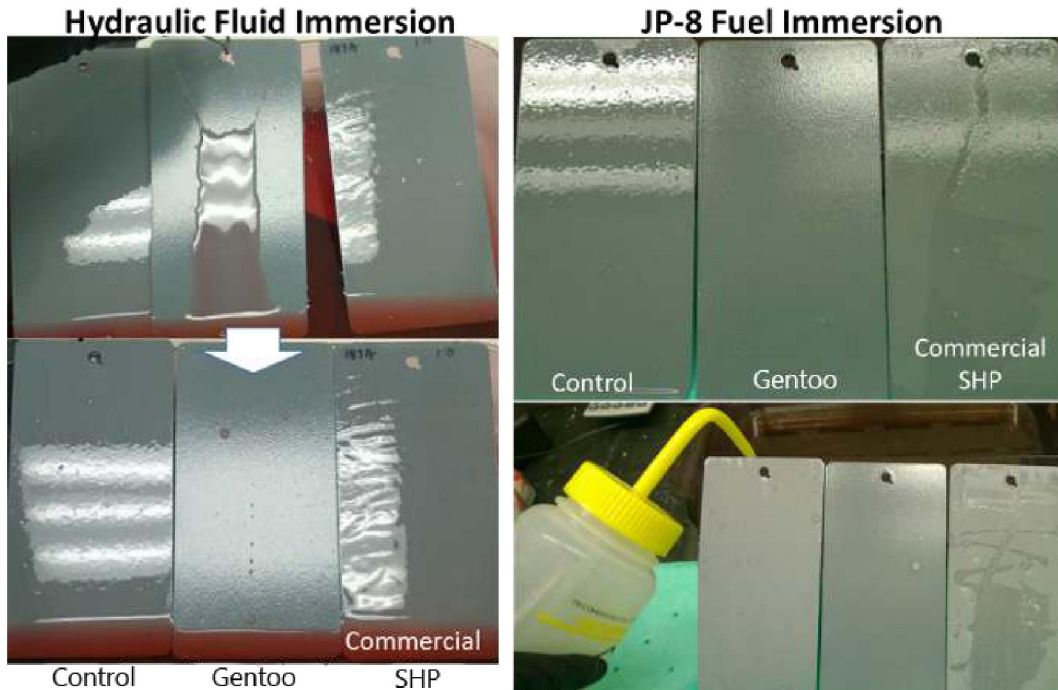
**Figure 1**

Fluid Immersion assessment of MIL-PRF-23377 Primer with MIL-PRF-85285D Topcoat painted aluminum panels untreated (control), Gentoo-treated, and commercial SHP treated in Hydraulic fluid at 66°C for 24 hours (Left) and JP-8 at room temperature for 7 days followed by an isopropanol rinse (Right)

Gentoo demonstrated no blistering or coating defects and maintained hydrophobic performance following immersion in aircraft deicing fluid, cleaning compound (degreaser), lubricating oil, hydraulic fluid and JP-8 fuel. The Gentoo was removed using the PR-3500 epoxy paint remover, as expected. Commercially available superhydrophobic (SHP) paint was also assessed, and that coating lost all superhydrophobic and hydrophobic performance after immersion in all fluids, and was completely removed when immersed in most fluids, except deicing fluids. Figure 1 exhibits some representative images.

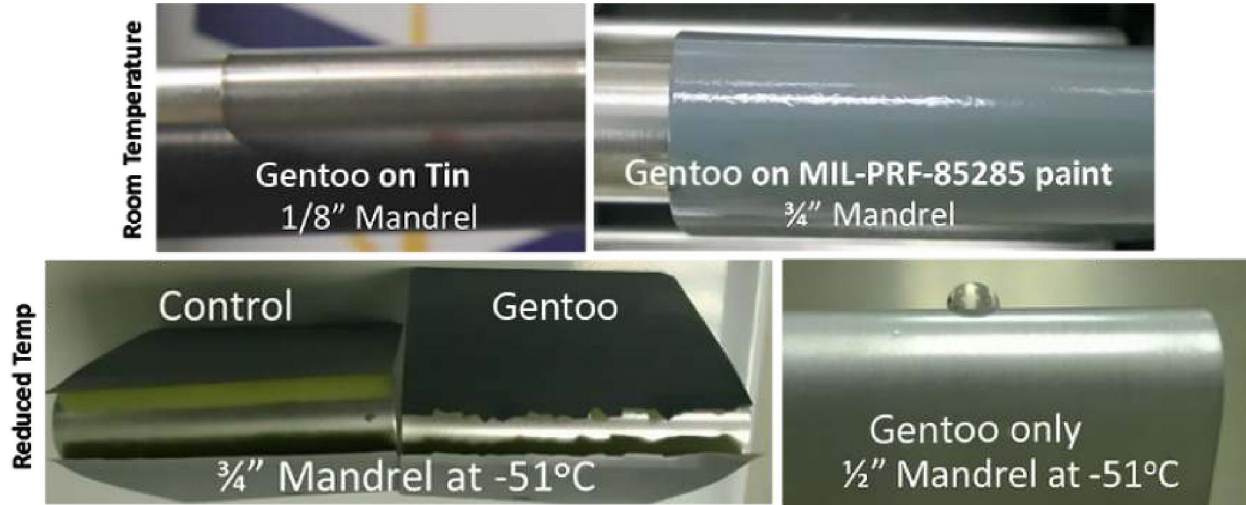
**Figure 2**

Mandrel Bend Flexibility of Gentoo Treatment at Room Temperature direct to metal and on MIL-PRF-85285 grey urethane topcoat (Top Row) and -51°C on MIL-PRF-85285 grey urethane topcoat (Bottom Row)

Gentoo exhibits excellent flexibility at room and low temperatures (Figure 2). Gentoo at -51°C bent over a 3/4 inch mandrel cracked during low temperature flexibility assessment, but failure of the primer - aluminum panel interface resulted in complete coating failure. The Gentoo was not the source of the failure and the ragged edges are indicative of the Gentoo attempting to keep the coating system together despite the delamination event. An aluminum panel coated only with Gentoo was reevaluated at -51°C and passed 1/2 inch mandrel bend. Hydrophobic performance of the Gentoo retained as evident by the water drop on the tested surface.

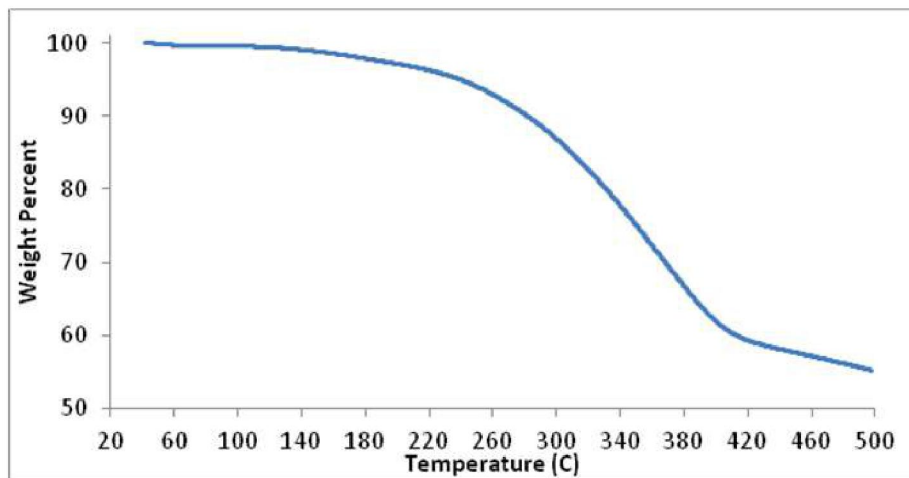
**Figure 3**

Decomposition TGA of cured, Gentoo formulation (ramp rate of 3°C/minutes)

Gentoo is stable up to 200°C according to Figure 3 TGA decomposition curve. Thus, the coating has a wide range of operating temperatures from -51 to 200°C.; however, for continuous use (as opposed to temperature spikes) we recommend a maximum operating temperature of 160°C

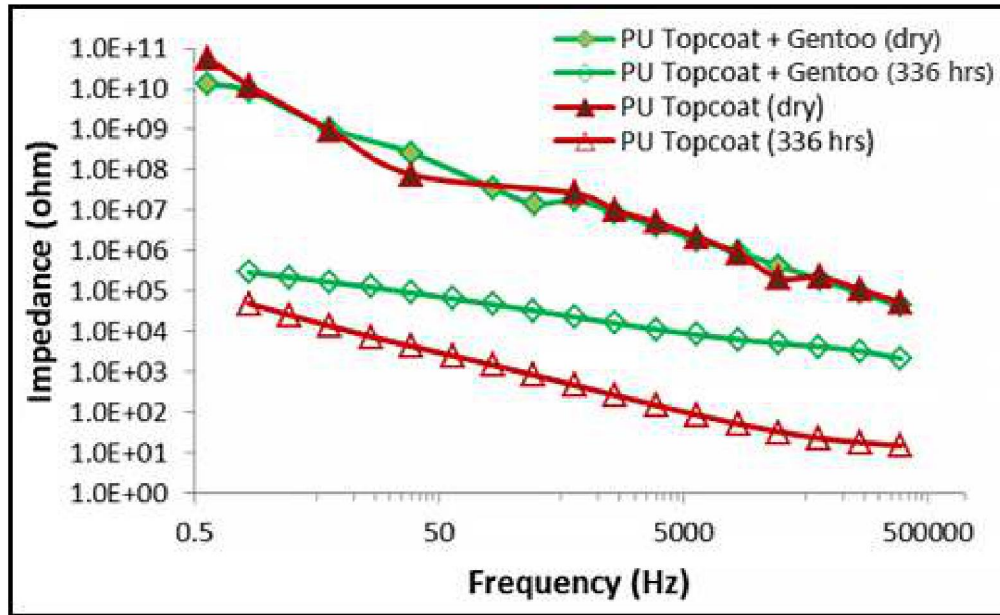
**Figure 4**

Electrochemical Impedance Spectroscopy (EIS) testing: MIL-PRF-85285D Polyurethane coated UNSA92024 aluminum alloy.

Electrochemical Impedance Spectroscopy (EIS) was used to evaluate the barrier properties of the Gentoo coating. Aluminum alloy UNSA92024 coupons were coated with MIL-PRF-85285D grey polyurethane (1.0 mil thick) and tested with and without the addition of Gentoo. Initial testing (i.e. “dry”) of the samples showed similar impedance across the full frequency range (Figure 4). After exposure to ASTM B117 salt fog conditions for 336 hours, the samples were retested. The polyurethane only sample showed a significantly larger reduction in impedance (~two decades) compared to the Gentoo, indicating significantly better barrier properties for the coupon.

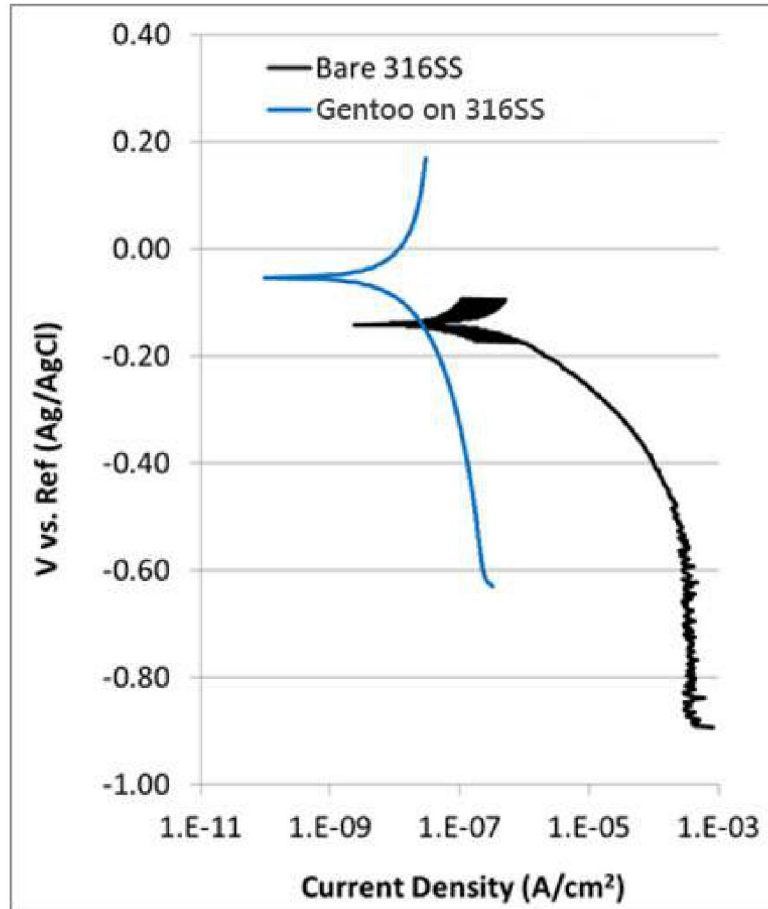
**Figure 5**

Polarization test results for a bare 316 stainless steel substrate compared to a similar substrate with Gentoo.

Galvanic corrosion around cathodic fasteners mated to anodic aluminum alloy structures is a common problem in the aircraft community. It is known that galvanic corrosion of aluminum is controlled by the available cathodic current, and that a reduction in available current should result in less corrosion damage. As an assessment of the possible galvanic protection attributes of Gentoo, polarization testing was conducted on a bare 316 stainless steel flat coupon and compared to a similar coupon with Gentoo applied. Results from the tests are observed in Figure 5. The addition of Gentoo resulted in an approximate two-order of magnitude reduction in cathodic current density compared to the bare 316 stainless steel coupon.

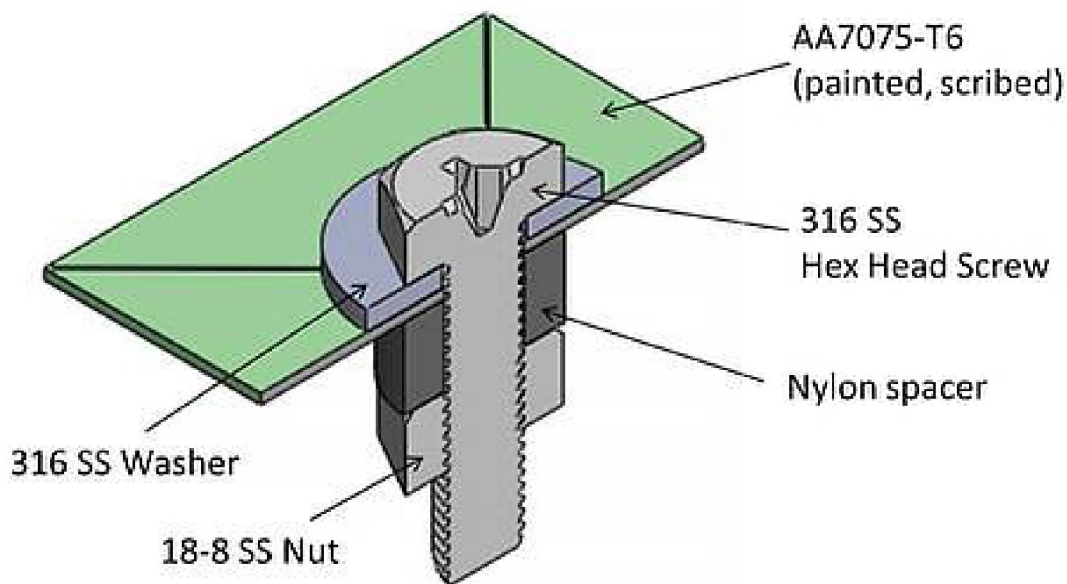
**Figure 6**

Schematic overview of the galvanic fastener assembly components used for corrosion assessment of Gentoo as applied to 316 stainless steel fasteners.

As a further assessment, several 316 stainless steel screws and washer assemblies were prepared bare, and separately coated with Gentoo. The fasteners were attached to primed and topcoated aluminum alloy 7075-T6 (UNS A97075) coupons and exposed to accelerated corrosion conditions for galvanic corrosion assessment. Specifically, the fastener assemblies consisted of ¼-20 x 1 inch full-thread screws and corresponding mated flat washers (Figure 6), with and without Gentoo. Select screws and washers were also cadmium plated per ASTM F1941 FE/CD 5A. The 7075-T6 aluminum coupons were approximately 1 x 1.375 x 0.032 inch and a ¼-20 drill and tapped hole was created in the middle region of each one for mated fastener attachment. All aluminum panels were initially deoxidized with Alumiprep 33 and treated with PreKoke, a non-chromate adhesion promoter for paints. Following

the pretreatment, a MIL-PRF-23377 epoxy primer and MIL-PRF-85285D grey polyurethane topcoat from PRC Desoto were applied to the surface. The coated coupons were hand-scribed to expose fresh, bare metal prior to fastener attachment. During galvanic assembly, nylon spacers and 18-8 stainless steel nuts were used on the backside of the aluminum coupons and torqued to 25 in-lbs. Each distinct assembly type was tested in triplicate via placement in ASTM B117 cyclic salt fog conditions.

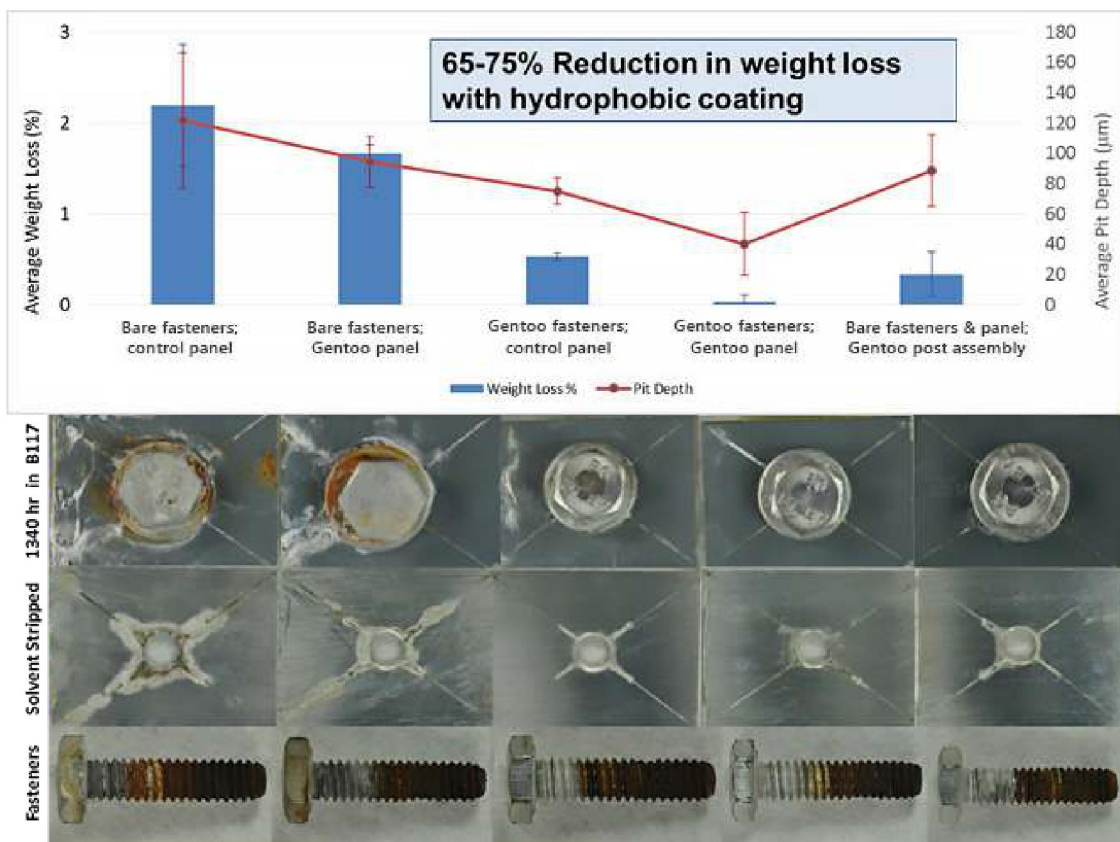
**Figure 7**

Galvanic Fastener Assembly Test Images of Cadmium plated B7 HSS bolts after 1340 hours of Salt Spray (top row images) and solvent stripped using ASTM G1, coated 7076-T6 aluminum panels (middle row) measured for weight loss and pit depth (accompanied graphs), and side images of representative fasteners (bottom row)

Bare B7 steel fastener and cadmium (Cd) plated B7 steel fastener assemblies were used for galvanic coupling with the scribed, painted aluminum panels. Control and Gentoo coated fastener assemblies were used. After 648 hours of B117 exposure, significant amounts of corrosion product was evident with the bare B7 steel fastener assemblies, while significantly less corrosion was evident after 1340 hours of salt spray with the cadmium plated B7 steel fasteners. The test assemblies were removed from B117, solvent stripped and cleaned using ASTM G1 guidelines and evaluated for weight loss and pit depth measurements due to corrosion. The parts were solvent stripped by first using a Rust-Oleum Aircraft Paint Remover soak at 49°C, followed by immersion in a 60-70% nitric acid stripping solution and rinsed with ethanol to remove any residue. Improved corrosion resistance from Gentoo treatment of

fasteners and painted panels were demonstrated visually, by corrosion based weight loss and pit depth measurements of the stripped aluminum panels on both the bare B7 and cadmium plated B7 fastener assemblies. The barrier effect of the Gentoo appears to be potentiated when combined with electrochemically deposited layers, such as Cd plating. Results are displayed in Figure 7.

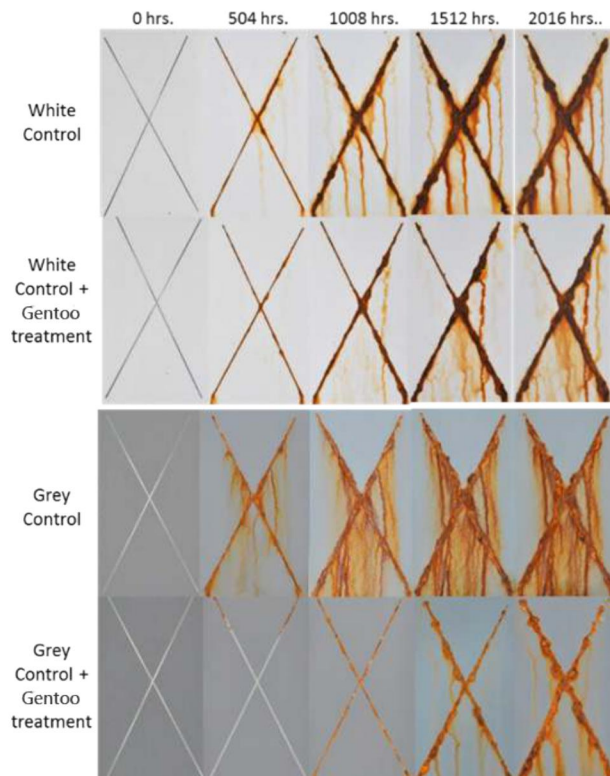
**Figure 8**

Images of MIL-PRF-32239 scribed LHE Zn-Ni 4130 HSS painted panels with either the MIL-PRF-85285 white glossy topcoat or the MIL-PRF-85285 grey semi-gloss topcoat with and without Gentoo following ASTM B117 Salt Fog Exposure

Accelerated ASTM B117 corrosion testing was performed on LHE Zn-Ni plated 4130 HSS painted panels. The flat panels were primed with a MIL-PRF-85582 Class N chrome-free epoxy primer and topcoated with a CA8201/F17925 MIL-PRF-85285 Type I Class H white glossy urethane paint, or a CA8211/F3673 MIL-PRF-85285E Type I grey semi-gloss paint. Control panels included the primer and topcoats only. Gentoo was applied to selected control panels. All panels were "X" scribed according to MIL-PRF-32239 and placed in ASTM B117 salt fog with images taken every 500 h. Figure 8 displays the salt fog exposed panel images for the white and grey topcoat controls and Gentoo treated panels. Significant amounts of red rust are present on all the panels with the onset of rust by 500 h of exposure. The scribe corrosion is rated according to ASTM D1654 for each of the panels and is graphically displayed in Figure 9. For both the white and grey topcoats, the Gentoo treatment significantly reduces the scribe creep.

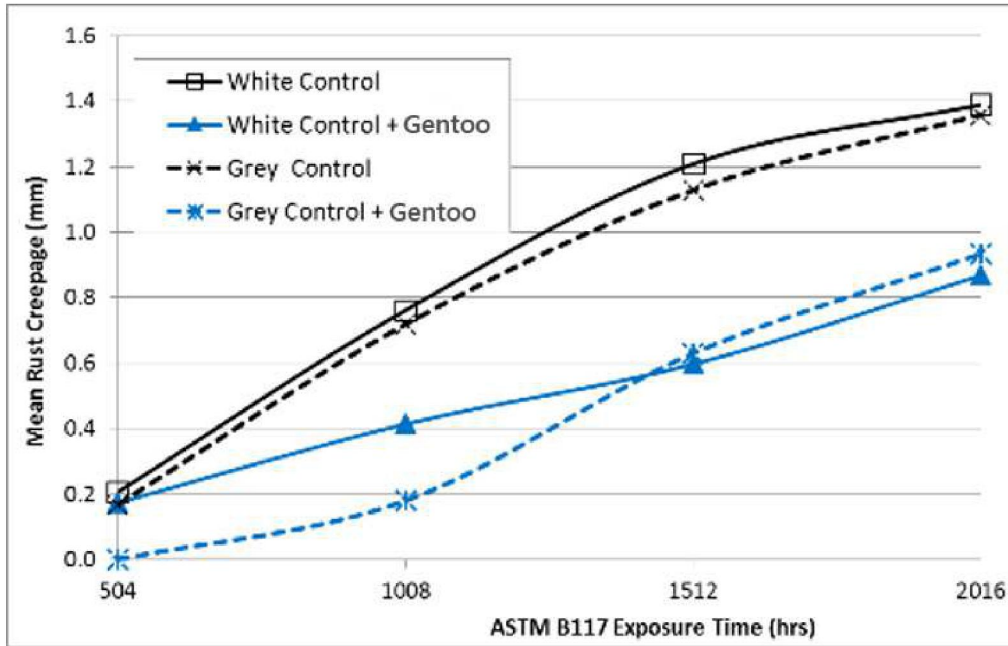
**Figure 9**

ASTM D1654 Scribe Corrosion Ratings of Scribed, ASTM B117 Salt Fog Exposed painted, LHE Zn-Ni 4130 HSS panels with and without Gentoo

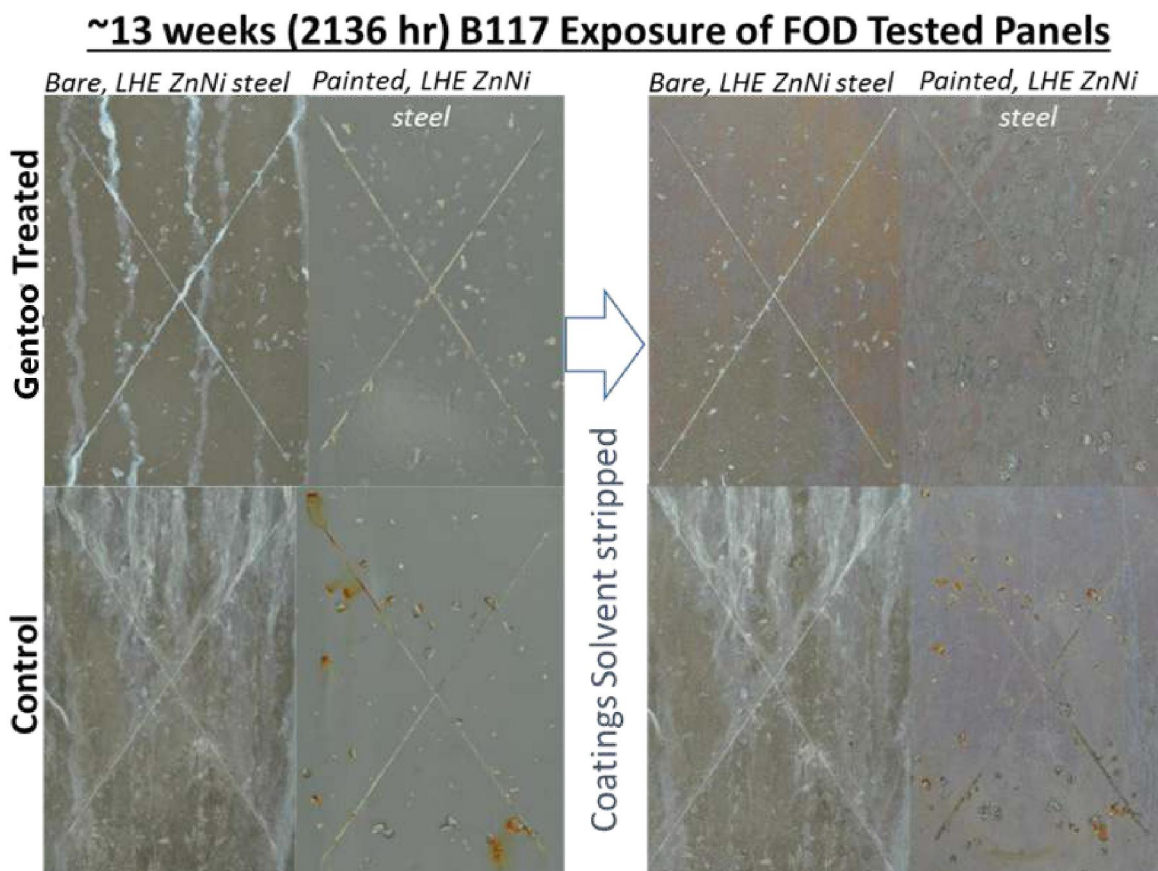
**Figure 10**

2136 hours of B117 Salt Fog Exposure of FOD Tested Bare and MIL-PRF-23377 primer with MIL-PRF-85285D topcoat painted LHE Zn-Ni plated HSS panels with and without Gentoo

UDRI performed chipping resistance testing on Gentoo treated and untreated LHE Zn-Ni 4130 steel panels, as well as on Gentoo treated and control MIL-PRF-23377 epoxy primer with MIL-PRF-85285D grey urethane topcoat painted LHE Zn-Ni 4130 steel panels. No reportable differences were observed in coating chip protection between the Gentoo treated and untreated bare steel panels. After chipping resistance testing, the damaged panels were placed into an ASTM B117 salt fog chamber. After 2136 hours of exposure, the Gentoo treated steel and Gentoo treated primed/topcoated, steel panels demonstrate significant corrosion improvement over the bare steel and painted steel control panels. This Gentoo treatment is providing added exposure protection as a function of impact over the control panels.

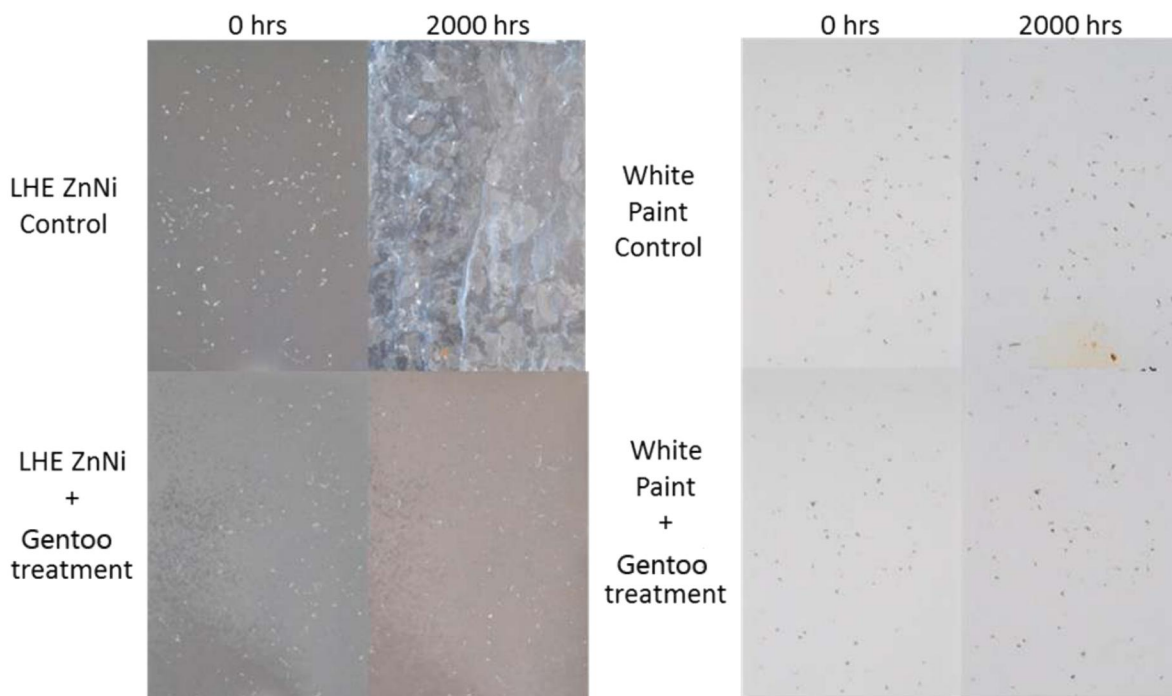
**Figure 11**

ASTM B117 Exposed, Chipping Resistance Tested LHE ZnNi plated 4130 HSS bare and painted panels with and without Gentoo

Chipping resistance testing was repeated with LHE ZnNi plated 4130 HSS panels with a MIL-PRF-23377J Type I Class N chrome-free epoxy primer and topcoated with CA8201/F17925 MIL-PRF-85285 Type I Class H white glossy urethane paint with and without Gentoo. Bare LHE ZnNi 4130 with and without Gentoo surface treatment was also included. No significant differences resulted in the chip protection ratings between the surface treated and untreated panels. Panels were placed into ASTM B117 salt fog for 2000 h of exposure. Red rust spots are visible on the painted control panel, while the Gentoo panels remain unchanged (Figure 11).

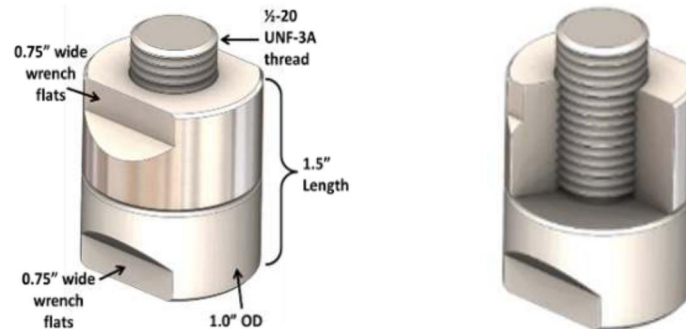
**Figure 12**

Example open-end threaded coupon for accelerated corrosion testing. Material of construction is 300M steel, as well as 7075-T6 aluminum female nuts with 300M male bolts for galvanic assemblies. The flat areas on each end will enable proper torque application. The design intent is to enable moisture ingress through the mated interface perimeter and along the thread interface, which characterize landing gear component configurations

Threaded parts designed to represent a landing gear gland nut assembly were machined 300M steel in an open-end component that is intended to focus corrosion along the male/female threaded interface, as well as the flat interface where the two coupon halves meet. An additional combination using 7075-T6 aluminum female parts mated to a 300M male parts are included in the evaluation, creating a galvanic interface similar to mated surfaces on landing gear wheel assemblies and higher corrosion potential than straight 300M interfaces.

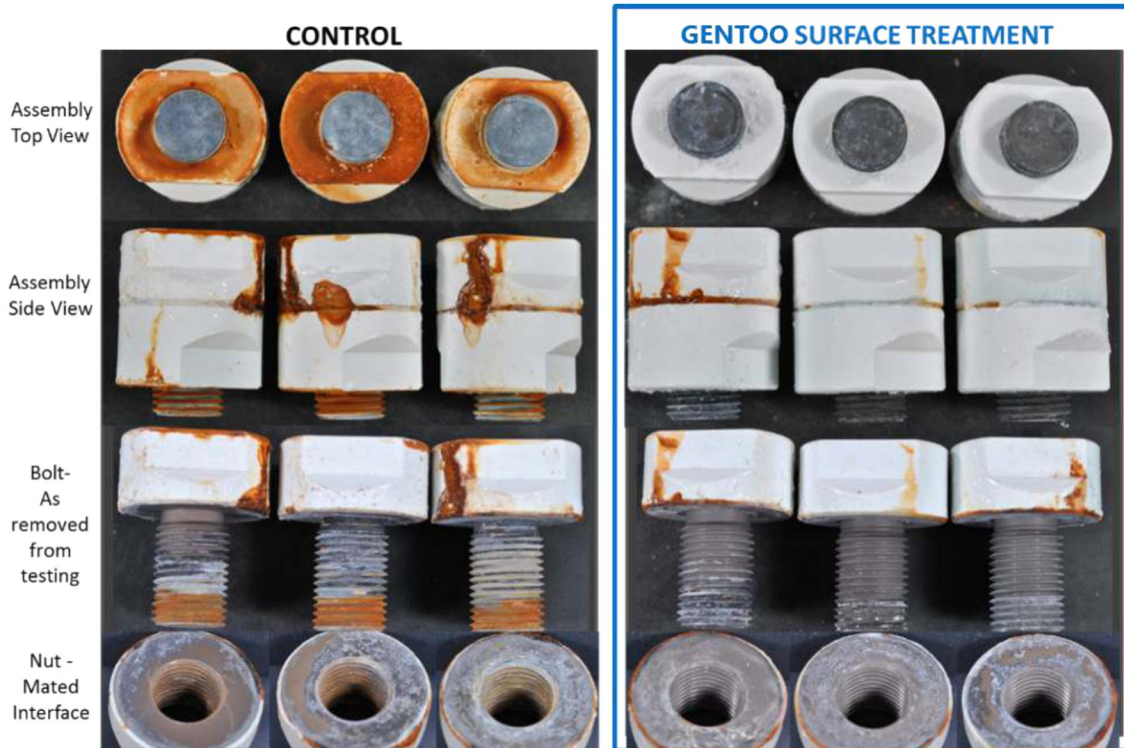
**Figure 13**

5040 h ASTM B117 Exposure of control and Gentoo treated (blue box) LHE Zn-Ni 300M threaded components, as removed from testing

Figure 13 through Figure 15 highlight the differences observed between control and Gentoo treated 300M parts following 5040 h of ASTM B117 salt fog exposure. The parts were removed from testing due to the quantity of red rusting on the exposed threads of the control sample. Upon disassembly, significant amount of corrosion and salt product (white build-up) was found on the unexposed threads of the bolt and nut of the control. The Gentoo treated sample unexposed threads are pristine and shiny on the nut and large sections of the bolt. Following media blasting, the Gentoo treated bolt and nut threads remained a light grey - indicating the undisturbed presence of LHE Zn-Ni (Figure 14). The control bolt's threads are dark and show areas of red rust following media blasting. Similar features are present on the threads of the control nuts (Figure 15). The darkening around the threads indicates that the LHE Zn-Ni plating was completely consumed during testing for both the control bolt and nut threads. The Gentoo provided significantly more protection to the 300M parts in ASTM B117. The USAF specified epoxy primer and urethane topcoat paint system based on their usage. Small blisters erupted on all of the LHE ZnNi 300M threaded parts following a few weeks of accelerated corrosion exposure in both ASTM B117 and GMW 14872. Further investigation revealed an incompatibility between the recommended primer and topcoat systems on LHE ZnNi HSS parts, resulting in blistering. The effects of the blistering are visible as dark spots on the stripped parts (i.e. Figure 15). The blisters were not observed during atmospheric exposure, nor do they appear to affect the corrosion results on the threads of the parts.

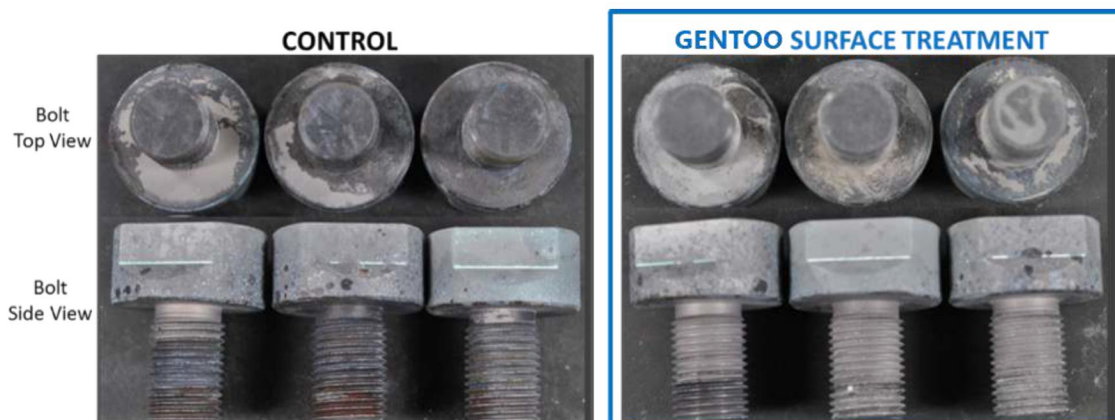
**Figure 14**

Plastic media stripped control and Gentoo treated (blue box) LHE Zn-Ni 300M bolts from 300M assemblies after 5040 h of ASTM B117 exposure

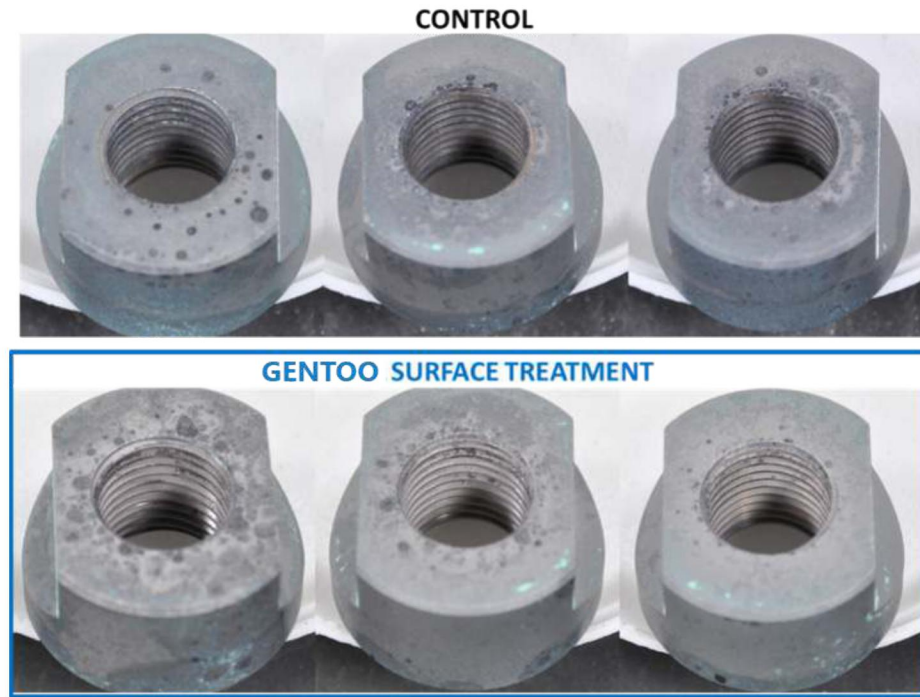
**Figure 15**

Plastic media stripped Control and Gentoo treated (blue box) LHE Zn-Ni 300M nuts from 300M assemblies after 5040 h of ASTM B117 exposure

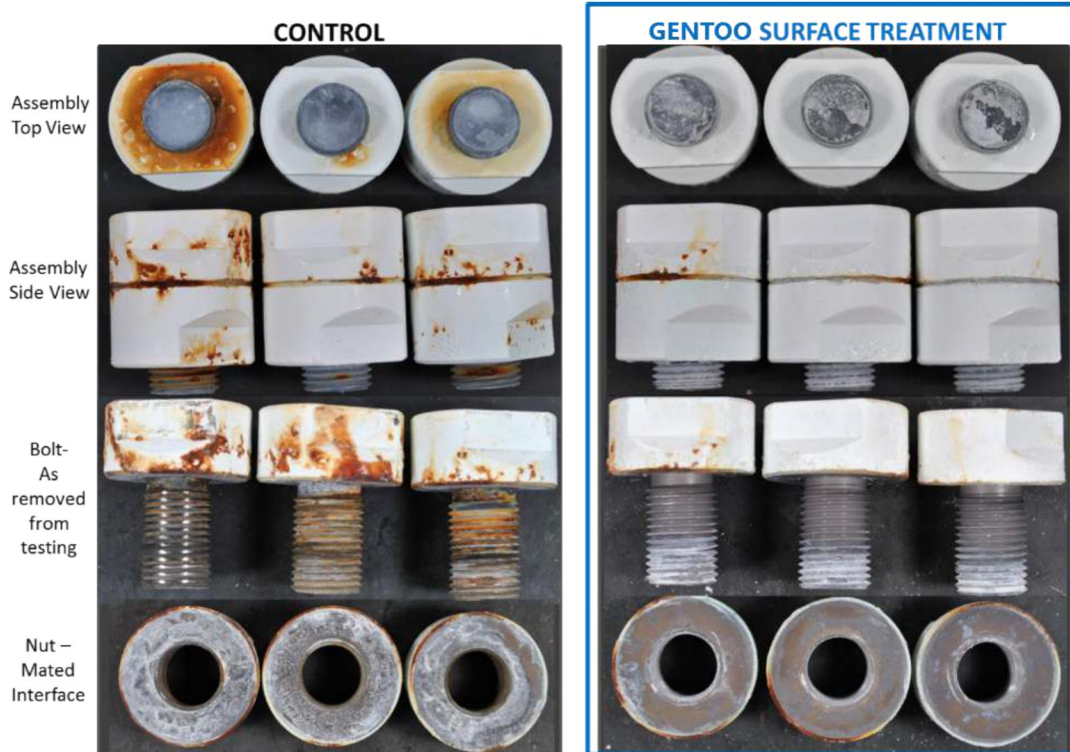
**Figure 16**

272 cycles of GMW14872 Exposure of control and Gentoo treated (blue box) LHE Zn-Ni 300M threaded components, as removed from testing

GMW 14872 exposure of the 300M threaded parts present similar results to those found following salt fog exposure. Figure 16 through Figure 18 show the control and Gentoo treated parts after 272 cycles (6528 h) of GMW 14872 exposure. The parts were finally removed from testing due to the presence of red rust on the exposed threads of the control samples. Both control and Gentoo treated threads had white product accumulated on the exposed threads. The white product was unable to be removed by washing or wiping from the control samples and was a product of LHE ZnNi consumption. The white spots on the Gentoo surface, however, could be rinsed off with water, as displayed on the tips of the threads in Figure 17, or removed with a gentle wipe. During GMW 14872 testing, there are a series of salt sprays during ambient conditions. Due to the hydrophobic nature of Gentoo, the spray beads up on the surface of the exposed threads. When the water evaporates, it deposits the salt behind, providing a site for further sprays to build up and deposit along. Despite the salt build-up, Gentoo continues to provide an excellent barrier from the corrosion inducing material and the LHE ZnNi and underlying 300M HSS is unaffected. The excellent protection provided by the Gentoo treatment is also evident on the unexposed threads of the bolt and nuts. The Gentoo treated parts are shiny, grey and pristine, while the control parts are dark and contain many areas with red rust.

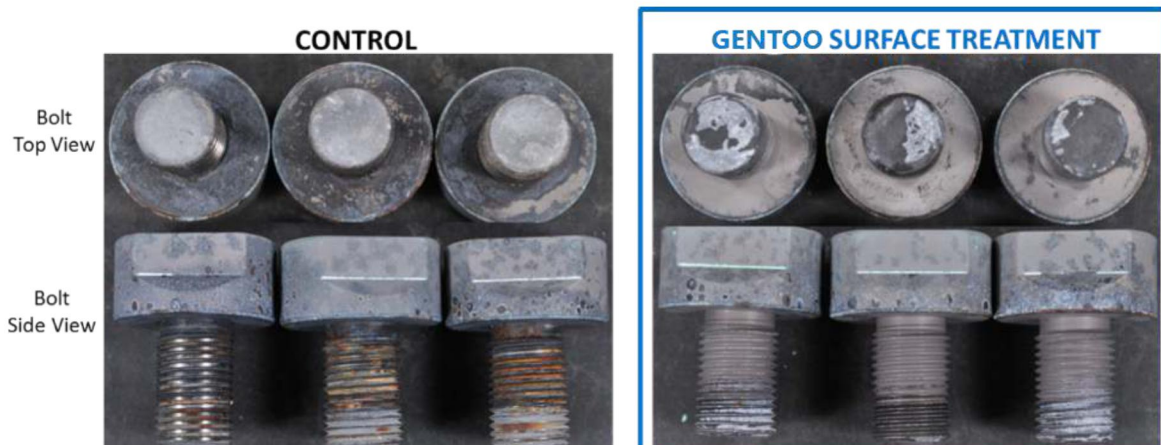
**Figure 17**

Plastic media stripped control and Gentoo treated (blue box) LHE Zn-Ni 300M bolts from 300M assemblies after 272 cycles of GMW14872 exposure

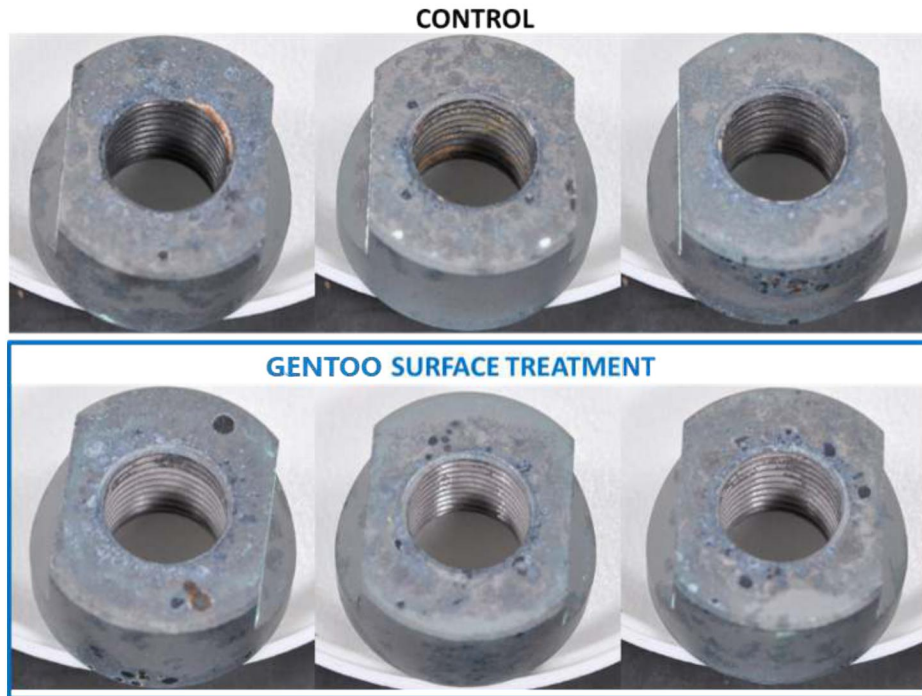
**Figure 18**

Plastic media stripped Control and Gentoo treated (blue box) LHE Zn-Ni 300M nuts from 300M assemblies after 272 cycles of GMW14872 exposure

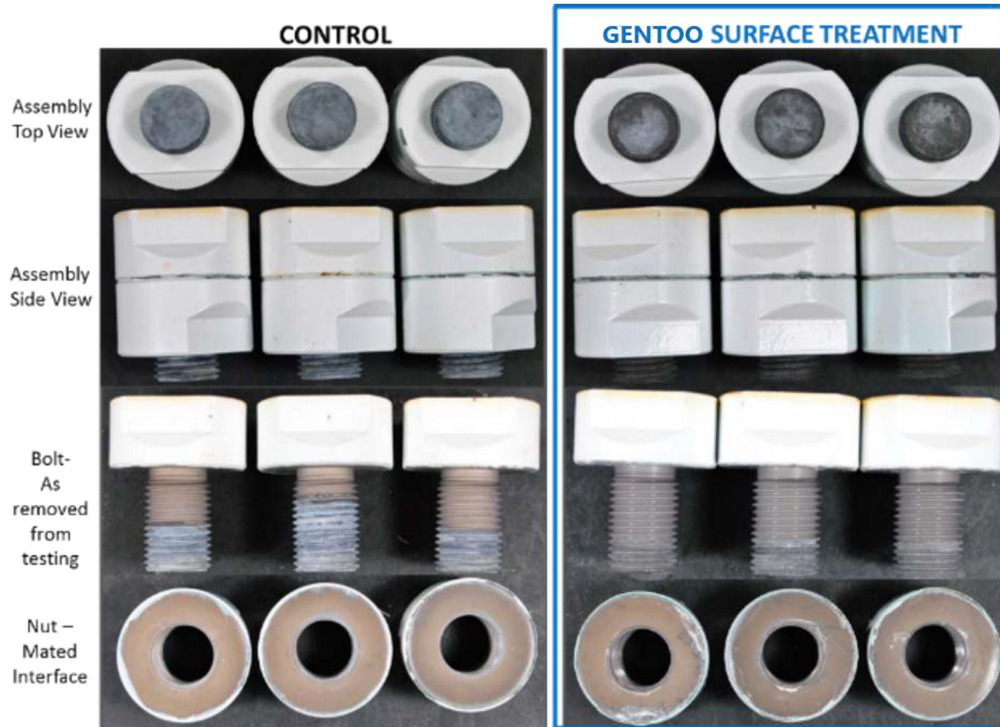
**Figure 19**

16 months of Kennedy Space Center, Florida beachside exposure of control and Gentoo treated (blue box) LHE Zn-Ni 300M threaded components, as removed from testing

Identical 300M threaded parts experienced 16 months of atmospheric exposure at Kennedy Space Center, Florida beachside. Images of the disassembled parts are displayed in Figure 19 and Figure 20. The exposed threads of the control assemblies show white LHE ZnNi consumption on the top and sides of the threads, while the Gentoo threads display minimal LHE ZnNi consumption. The inner threads of the Gentoo bolts are shiny and unchanged, while LHE ZnNi consumption down the threads toward the bolt head is obvious for the controls. Similarly, the inner threads of the Gentoo treated nuts are unaltered, while LHE ZnNi consumption is observed in the control threads.

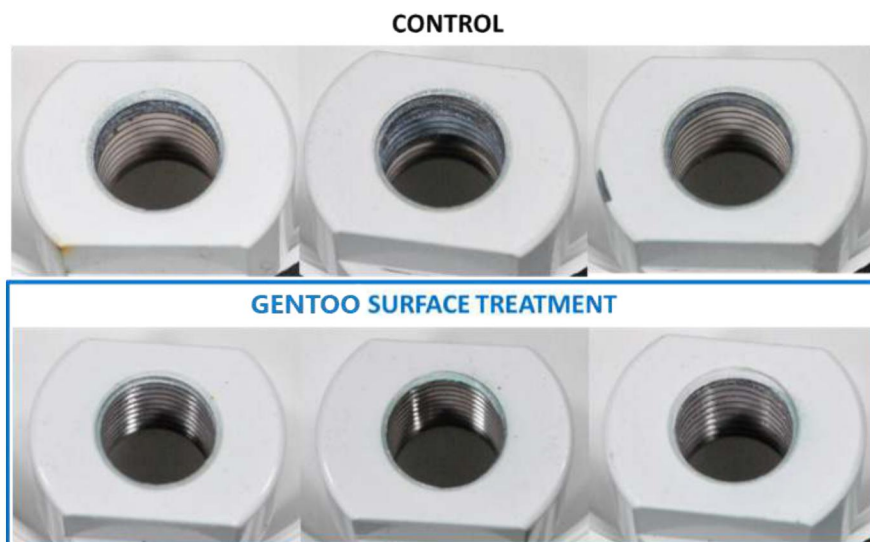
**Figure 20**

Control and Gentoo treated (blue box) LHE Zn-Ni 300M nuts with a view of inner threads from 300M assemblies after 16 months of Kennedy Space Center, Florida beachside exposure
